Draft Report

Drinking Water, Sewer, and Stormwater Infrastructure

Village of Cold Spring

4/14/2008

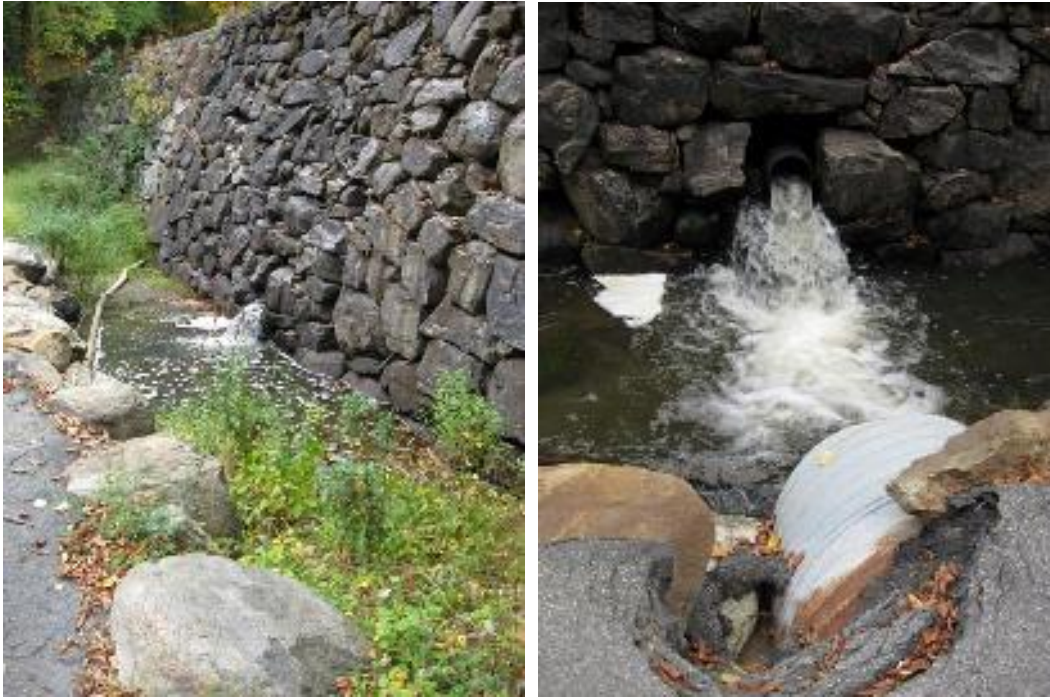
Water exiting the middle dam to feed Foundry Brook (note the crumbling pavement) (10/2007)

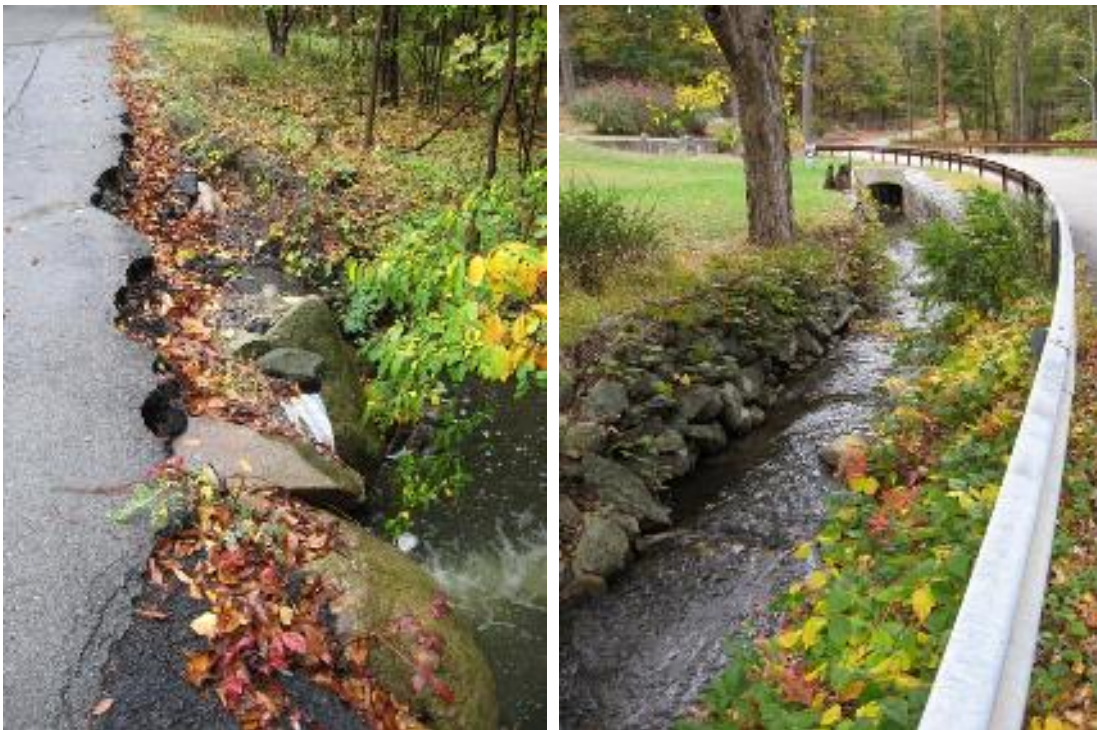
Despite these protections, during a brief survey of the Foundry Brook watercourse several potential violations were noted. I plan to contact the Village Board to recommend as a first step that they contact all property owners along the brook to inform them of the existing laws.⁴

Spots like this are where water supply is most vulnerable to pollution (10/2007)

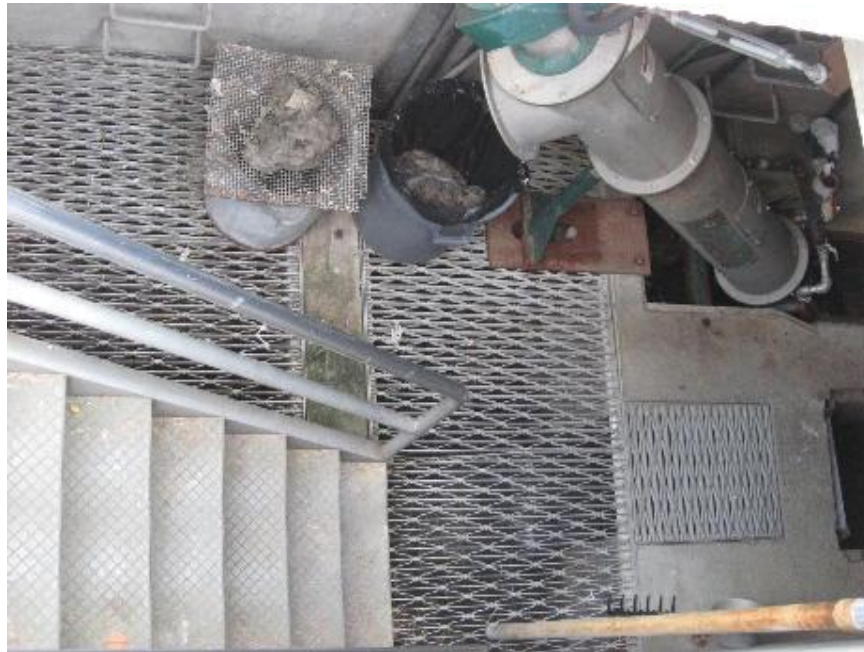
The Water Superintendent plans to relocate the auger unit downstream of the initial raw sewage pumps (located in the machine room in the basement of the facility) where there is plenty of pressure. This will also make the auger easier to access for maintenance. Relocating the auger unit will not help the raw sewage pumps, but these are large and not as susceptible to problems caused by solids. However, it will help everything downstream of the auger unit, especially the sludge return pumps, since solids in the sludge bind up the impeller and make these smaller pumps less efficient and susceptible to overheating.

Auger unit currently located in wet well (rags removed manually) (10/2007)

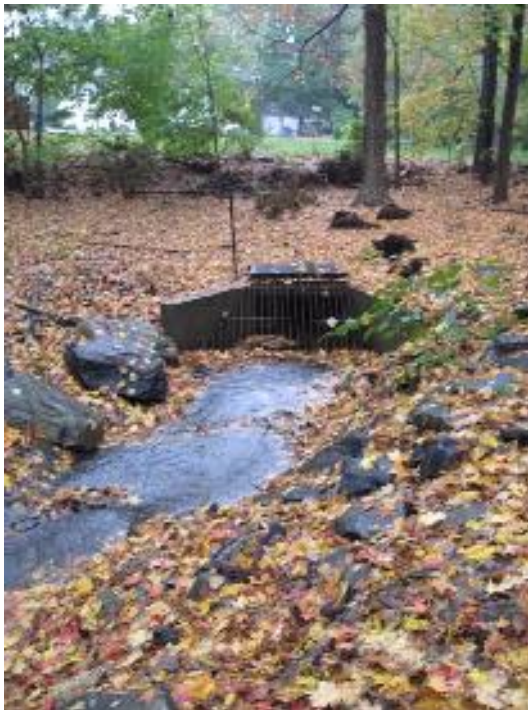
The start of "Back Brook" on Cedar St. (10/2007)

There are several points of constriction along the brook. The first is at Cedar Street where the flow first goes underground. Based on flooding in that area, it is possible the pipe may be too small to handle peak flows. However, the entry point is frequently constricted by leaves, branches and other debris so the flooding could be caused by that; further investigation is required, and enlarging the pipe may simply push the problem downstream where areas would be subjected to higher flows. The same applies to other constriction points.

In April 2007, the entrance to the piped section by Cedar Street (in Nelsonville) became partially clogged with branches and debris, and the whole basin area flooded causing flooded basements and other water damage. FEMA reviewed the damage but declined to assist, apart from \$1,116 for labor and equipment used to clear catch basins.

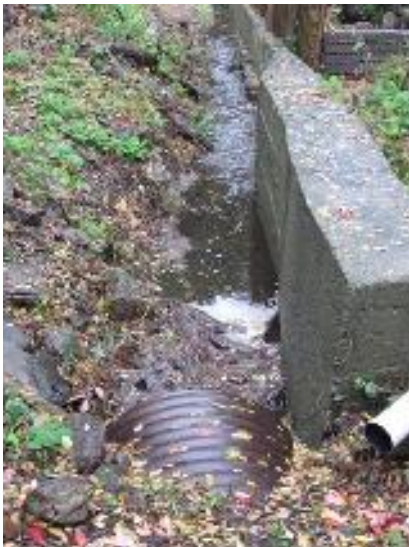
Between Church and Garden St. (10/2007)

At the point where the brook resurfaces between Church and Garden Street the DEC noted a lot of silt in the channel. The brook jumped the bank and flooded a few Garden Street properties in the spring of 2007. The DEC suggested digging out the silt and building up the channel sides but pointed out that this is not a long term solution as it will force the high flows somewhere else, perhaps onto another neighbor's property. A "rain garden" at the back of the flower shop parking lot might help improve ground absorption at that spot but a proper hydrological study is required before making any changes.

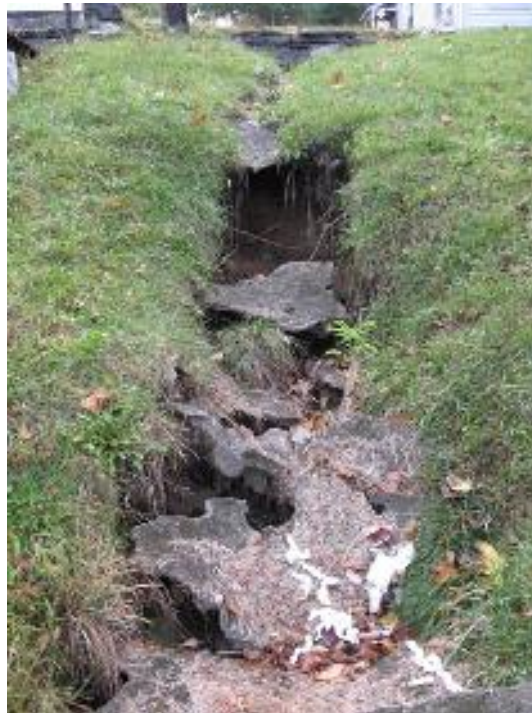
Typical street drainage (Paulding Ave) (10/2007) Problem spot by Maple Terr. stairs (10/2007)
