Draft Report

Drinking Water, Sewer, and Stormwater Infrastructure

Village of Cold Spring

4/14/2008

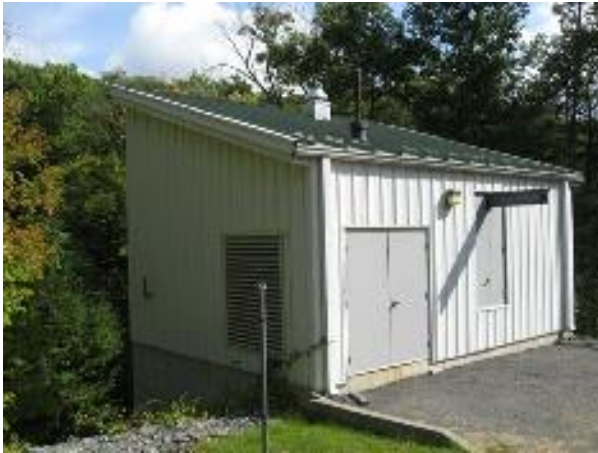
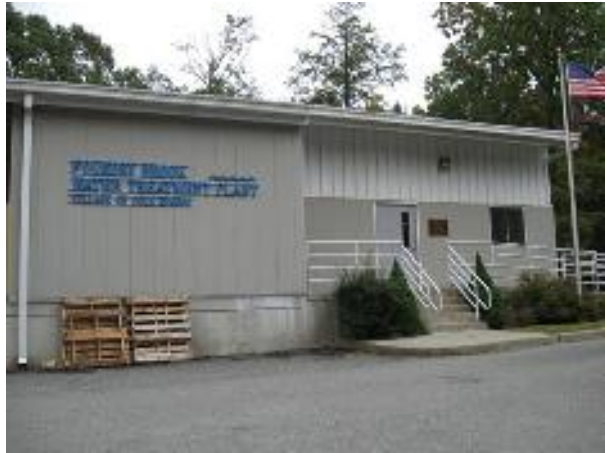
Pump house and water treatment plant (10/2007)

The biggest problem at the plant has been corrosion due to the high moisture level in the air. Also, moisture getting into pneumatic valves has caused failures. They are currently installing a dehumidifier to rectify this. Once installed they will scale down the rust and recoat the pipes, etc. and they should stay that way.

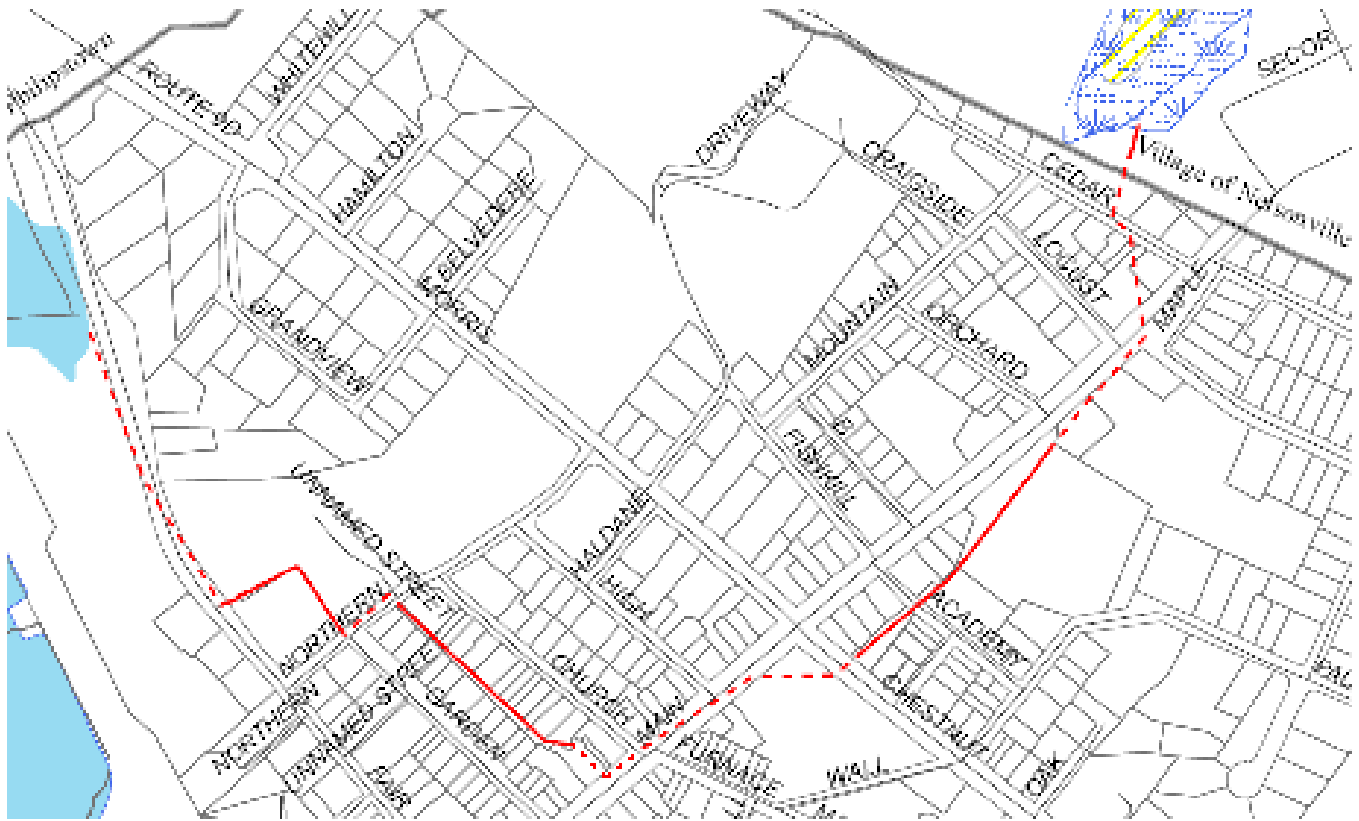
Approximate path of “Back Brook” (dotted sections run underground) (Peter Henderson, 10/2007)

There are several points of constriction along the brook. The first is at Cedar Street where the flow first goes underground. Based on flooding in that area, it is possible the pipe may be too small to handle peak flows. However, the entry point is frequently constricted by leaves, branches and other debris so the flooding could be caused by that; further investigation is required, and enlarging the pipe may simply push the problem downstream where areas would be subjected to higher flows. The same applies to other constriction points.

In April 2007, the entrance to the piped section by Cedar Street (in Nelsonville) became partially clogged with branches and debris, and the whole basin area flooded causing flooded basements and other water damage. FEMA reviewed the damage but declined to assist, apart from \$1,116 for labor and equipment used to clear catch basins.

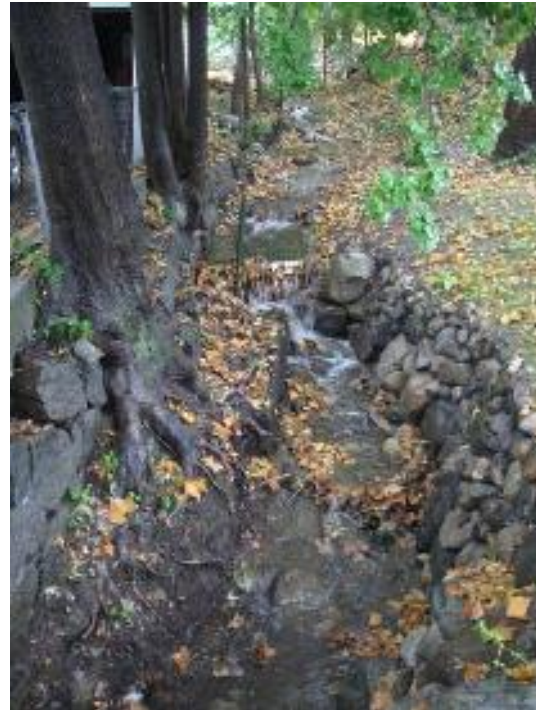
"Back Brook" by Academy St. (10/2007)

Although once a natural stream, sections of the brook have been diverted through ditches and otherwise irreversibly transformed over the years as Cold Spring has been built up. There is little natural habitat left to protect through the village. The stream is severely constrained by drainage structures, with little or no floodplain remaining for the stream. Restoring the stream to a pre-existing "natural" condition would be impossible because the floodplain is now occupied by houses, parking lots, roads, and other structures typical of urban environments. The DEC (Department of Environmental Conservation) uses the term "urban stream syndrome" to describe this situation of ecological degradation where streams flow through urban land. Because of the lack of natural habitat and because of the stream's intermittent flow, the brook no longer meets the DEC criteria for mapping as a protected watercourse.

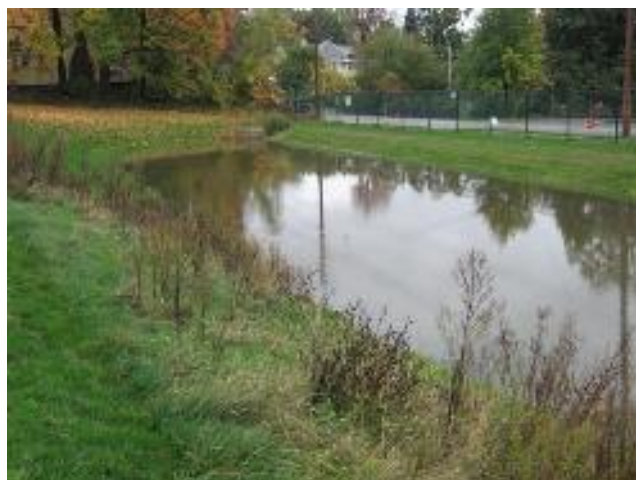
Lower detention pond beside Morris Ave (9D) (10/2007)

The "trickle tubes" are designed to slow down the rate at which water is released from the ponds. At the bottom of each trickle basin is a six inch hole that allows water to "trickle" out of the basin. During the average rainstorm, water is collected in the detention basin and released slowly, allowing the water drain over a period of time. Further up on the trickle basin are four six inch holes positioned so runoff from the "10 year storm" is released at a controlled rate, albeit faster than the normal storm. The grate at the top of the trickle basin releases water from the "50 year storm" and is designed so the detention basins do not overtop and flood 9D.¹²

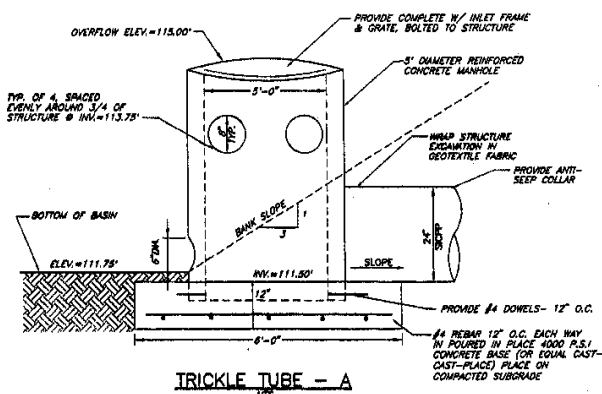
"Trickle tube" design (Haldane School)

Stormwater from the Haldane elementary playground area is captured in catchbasins and piped underneath the school property and then discharged to flow along the edge of Craigsides Drive. Water flows into a catchbasin at the foot of the Craigsides Drive and then joins the main stormwater piping under Morris Ave.

The Craigsides Drive catch basin is undersized for the quantity of water it must handle during heavy rains and sometimes overflows, creating flooding on Morris Ave. The village applied for a \$25,000 NYS grant to redo the catchbasin and the piping under Morris Ave, which is also inadequately sized. The grant would also cover widening of Morris Ave for school dropoff.

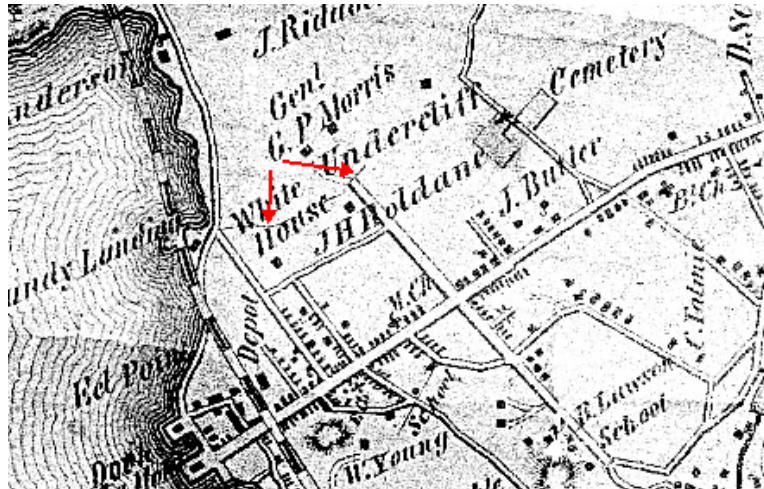
The map below is from an 1854 O'Connor map and shows a watercourse running from the Haldane property down to the river. This stream no longer exists so it may be possible that this flow was diverted at some point in the past and is contributing to the flow down Craigside Drive, although this is pure speculation at this time.

1854 O'Connor map showing stream on Haldane property

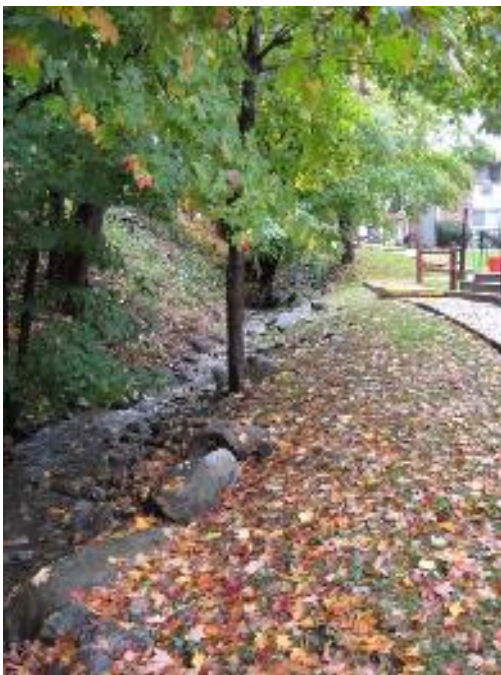
The two flows from the Haldane property (via the playing field detention ponds and Craigside Drive) combine with the street runoff from 9D and are piped down Northern Ave. The Northern Ave stormwater then combines with the water from Back Brook and flows through the Springbrook condominiums, under Fair Street, and into the cove.

Brook through Springbrook (10/2007

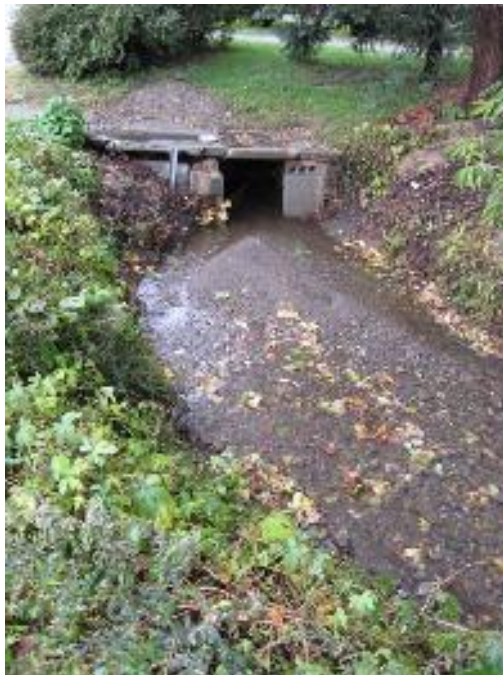
Brook entering piping under Fair Street (10/2007)

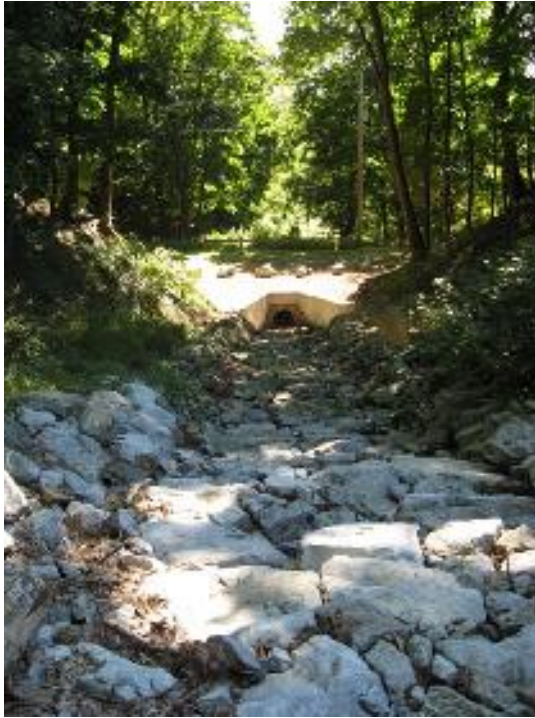
Catchbasins along Chestnut Street from St. Mary's Church to Chestnut Ridge capture street runoff from 9D and the Foodtown parking lot. Piping transports this runoff under Benedict Road and the Marion Ave extension and discharges it into a rip-rap gully that empties into the Foundry Cove.

Stormwater gully off Marion Ave ext. (10/2007)

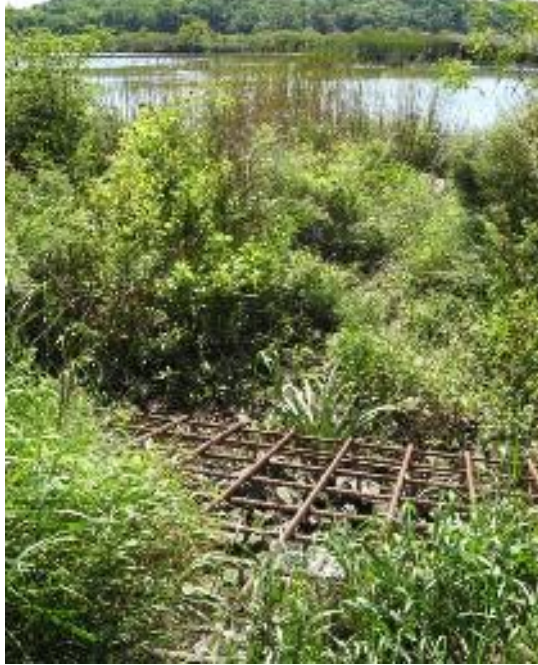
Discharge point at Foundry Cove (10/2007)

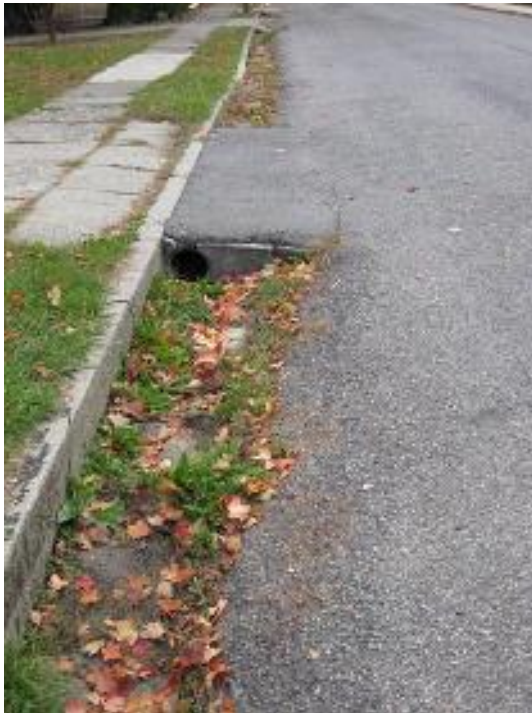
All other sections of the village lack any stormwater capture system, so water flows over the street the surface. The northern sections of Fair, Garden, and Church Streets pitch towards Northern Ave. The Parrott/Parsonage area drains into the Foundry Brook. The Hamilton/Belvedere area drains towards Mayor's Park. Mountain Avenue drains to the catchbasin on Fishkill Road.

Typical street drainage (Paulding Ave) (10/2007) Problem spot by Maple Terr. stairs (10/2007)
